GL1500 CB RADIO SUB-HARNESS

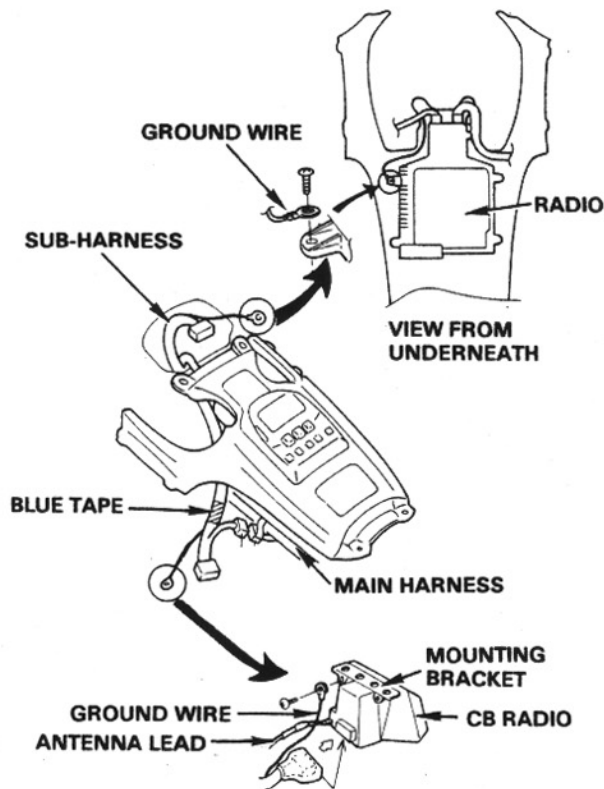
IDENTIFICATION

For future identification, remove the left fairing side pocket. A ground wire attached to the CB mounting bracket indicates the new sub-harness (or a CB with serial number 6656 or above) has already been installed. The sub-harness for this repair is also wrapped with blue tape in the area shown above.

Installation instructions are included with the sub-harness kit. Follow the instructions carefully for proper sub-harness installation.
