1988/1989 GL1500 IMPROVED WINDSHIELD SEAL

(This supersedes GL1500 #5, dated November 1989)

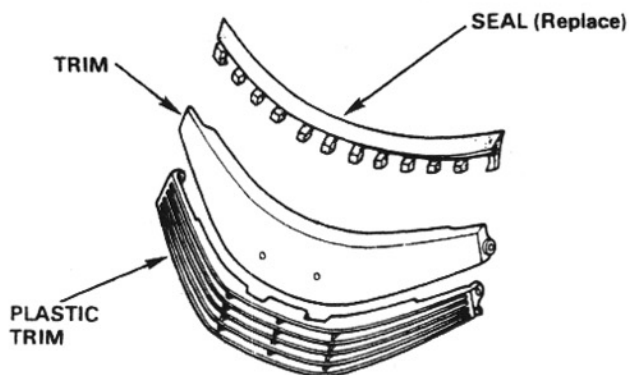
An improved windshield seal for 1988 and 1989 GL1500s is now available. This thicker seal is used on the 1990 GL and helps retain the shield in its fixed position.

In addition to the new seal, properly adjusting the windshield lever anchor screws will prevent a loose or slipping shield.

1. Remove the mirrors.
2. Remove the black plastic vent trim.
3. Remove the two screws securing the windshield trim. Free the tabs from the fairing slots and remove the trim.
4. Remove the existing seal from the back of the trim. Clean the windshield and seal mating surfaces with warm soap and water — dry completely.

5. Peel off the tape backing on the new seal. Press the seal into position on the trim.
