# Service Bulletin

## 2001-2002 GL1800A ABS Speed Sensor Wire Clamp Location

**GL1800 #9  
DECEMBER 2001**

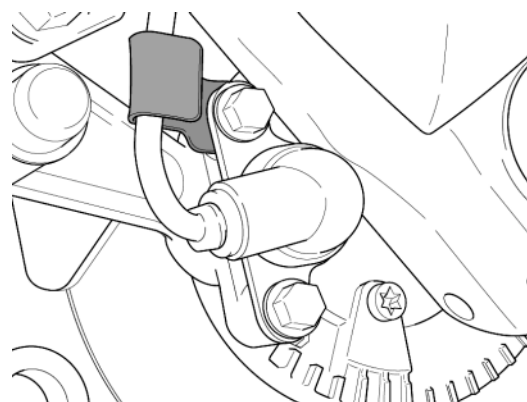
If the speed sensor wire clamp for the front ABS speed sensor is installed incorrectly, the ABS speed sensor air gap may be out of specification. This does not affect ABS speed sensor operation, but the clamp should be installed correctly.

**INCORRECT Installation**

3. If the clamp is installed incorrectly **under** the speed sensor, remove and reinstall the clamp and speed sensor correctly. Torque the bolts,.

**Torque: 12 N•m (1.2 kgf•m, 9 lbf•ft)**

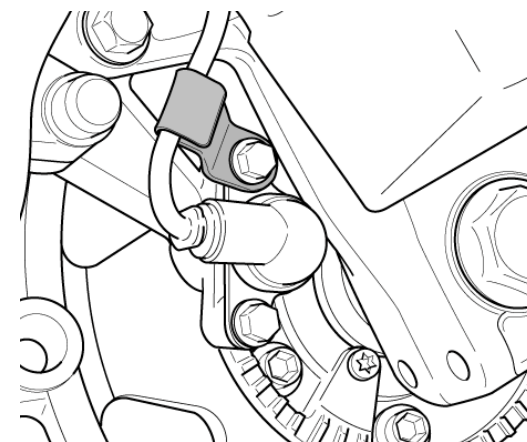
**CORRECT Installation**

2. If the clamp is installed correctly on **top** of the speed sensor, no further action is necessary.
